Photographs of select violations of wetland and waterway permit conditions along the Enbridge Construction Corridor. Wisconsin Wetlands Association (WWA) compiled the photos from daily reports submitted to WDNR by Independent Environmental Monitors assigned to monitor the environmental performance of Enbridge's construction crews.

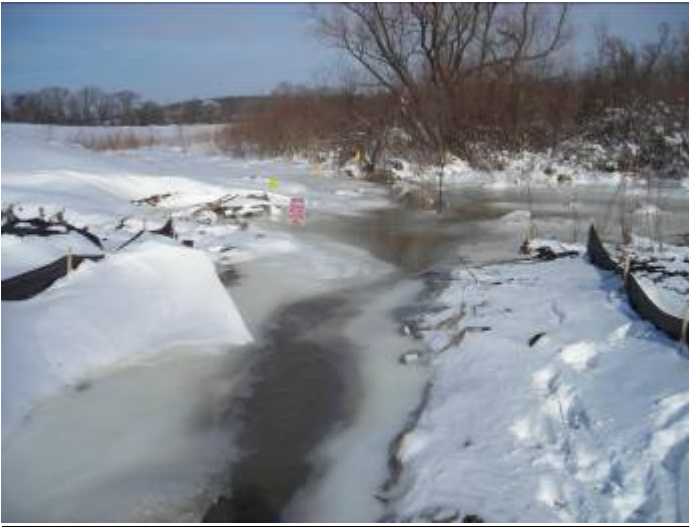
**MP 317.3. Silt fence does not extend across entire disturbed ROW
Report 4-DD-102 - 2/7/08**

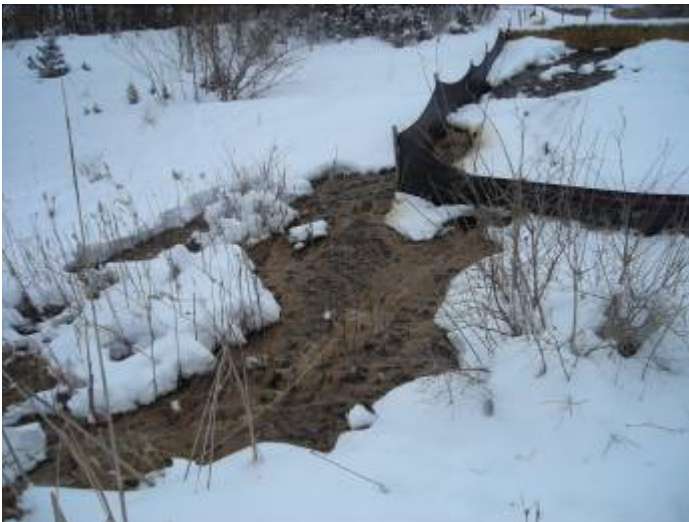
**Sediment-laden water flowing into Wetland CO-W17
Report 4-DD-097 - 1/26/08**

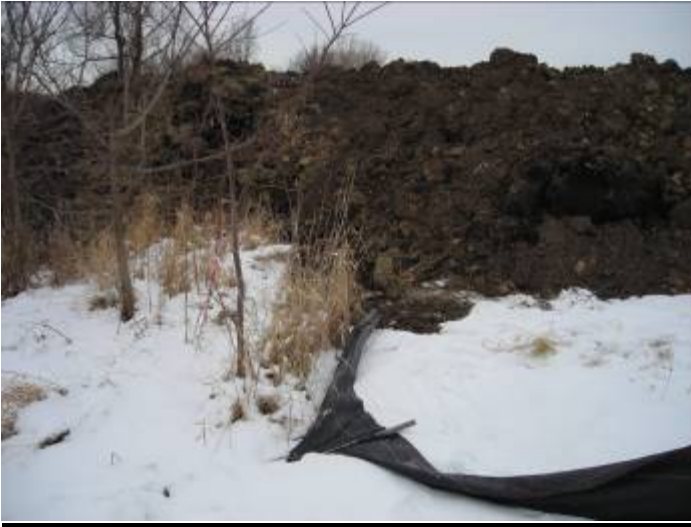
**Wetland and upland spoil not separated at DA-W5 boundary
Report 4-DD-094 – 1/16/08**

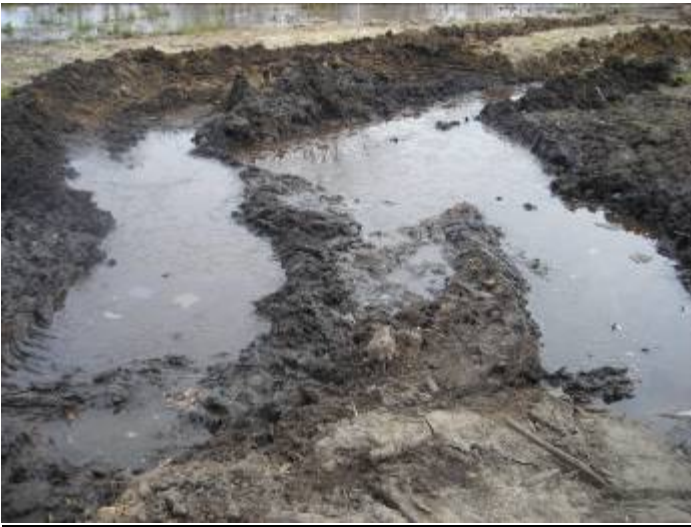
**Location where track hoe walked off the mats in Wetland
Report 4-DD-076 – 11/10/07**

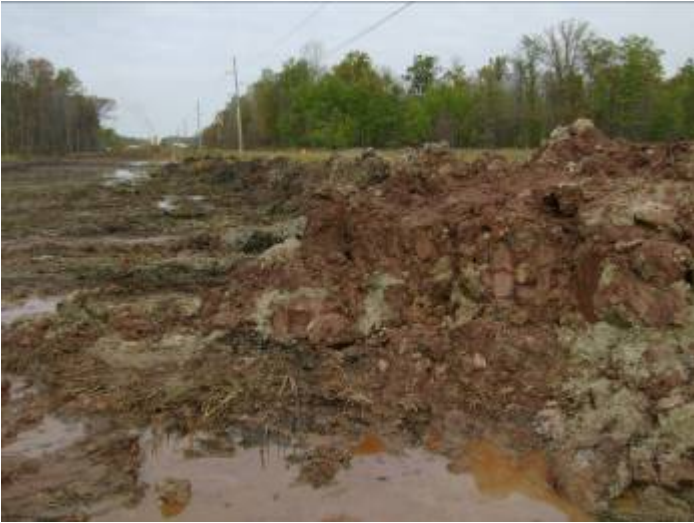
**Wetland WO-W48 subsoil on topsoil
Report 3-JV-019 – 10/13/07**

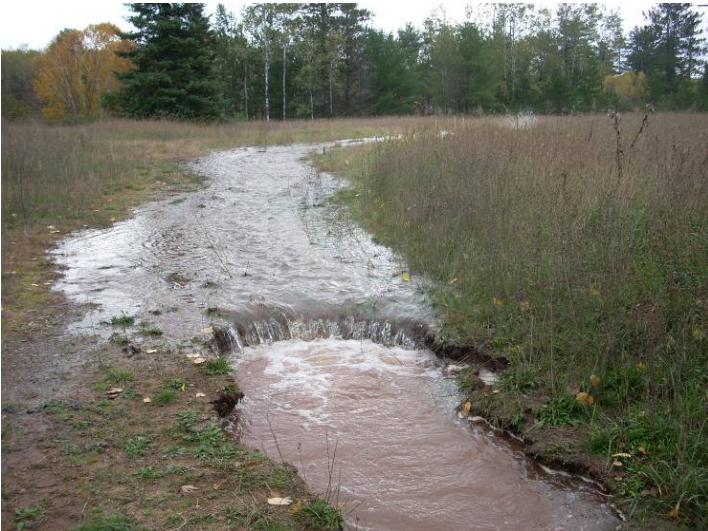
**Eau Claire River, DO-S22, Overland Pump Around Scouring
Report 1b-ST-015 – 10/11/07**

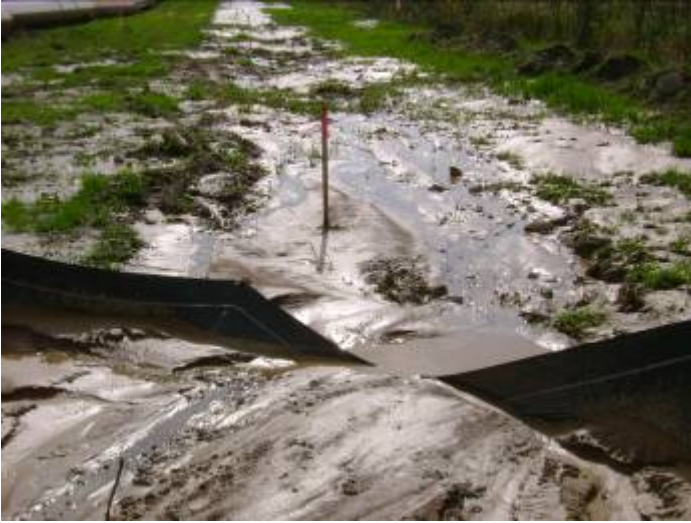
**North end wetland RU-W83. Sediment entering wetland where silt fence is in need of repair.
Report 2-JV-116 – 10/6/07**

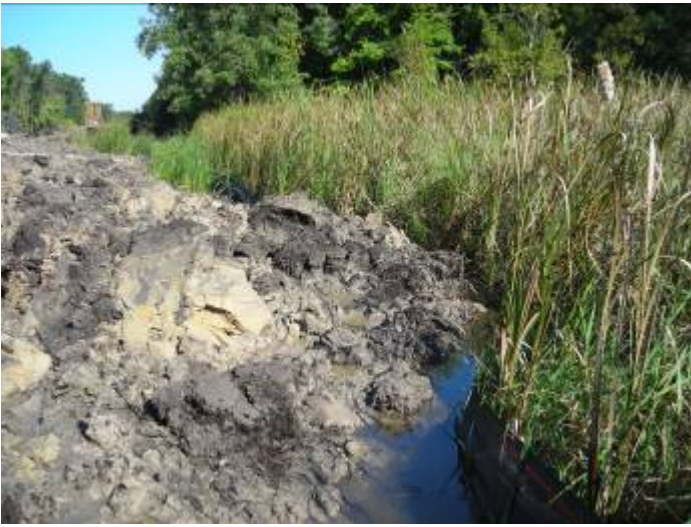
**Spoil outside eastern edge of ROW in Wetland
Report 4-DD-048 – 9/8/07**

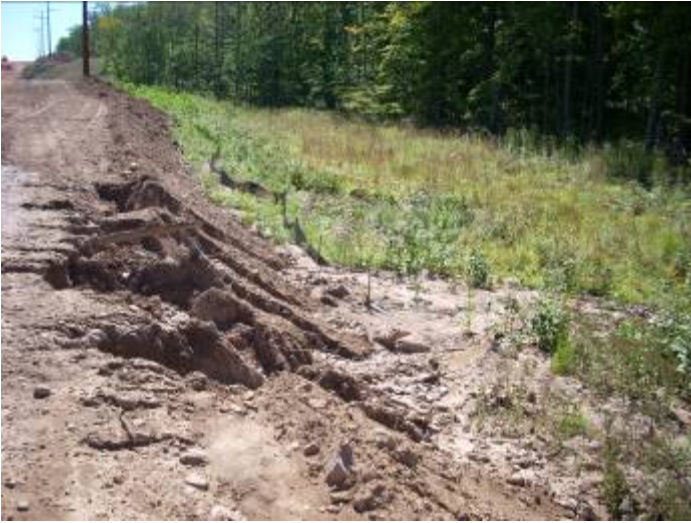
**Sediment, ECD Blowout in wetland
Report 1C-ST-020 – 8/30/07**

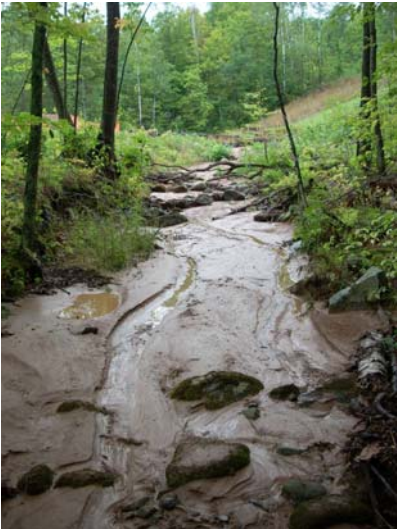
**Trib to Hauer, SA-S3, Downstream Sediment Deposit,
Sediment Extends 100 yds to the West of ROW
Report 1C-ST-019 – 8/28/07**

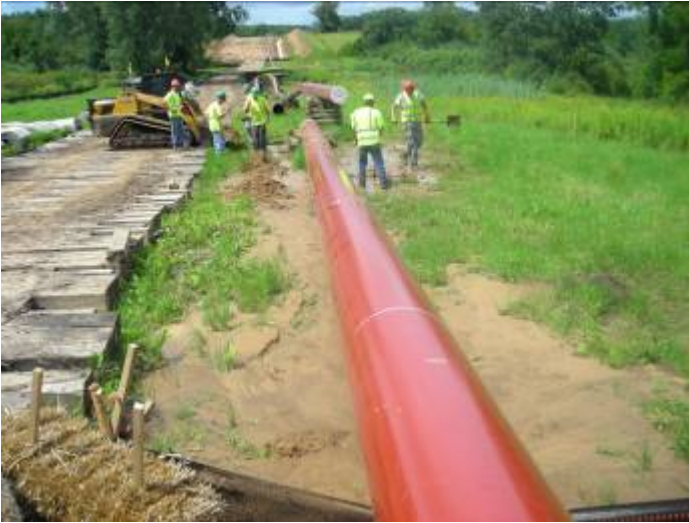
**Sediment deposited in Wetland CO-W23
Report 4-DD-027 – 8/7/07**

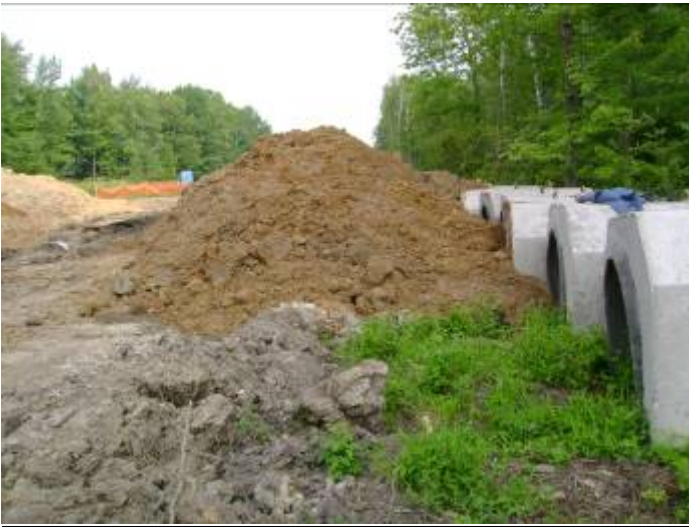
Sub-soil on topsoil, wetland. Report 2-JV-072 – 7/24/07
