Exploring the Relationship between Wetlands and Flood Hazards in the Lake Superior Basin

June 2018

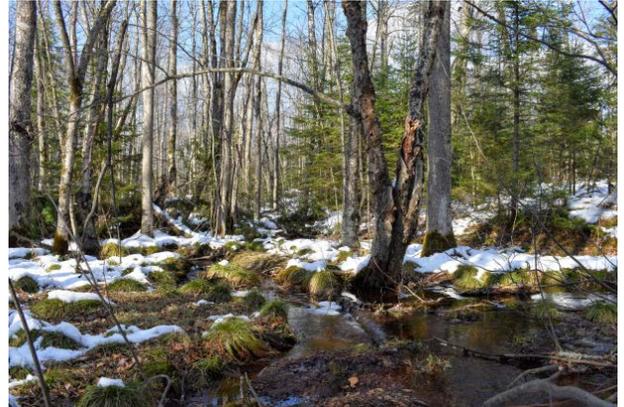
Figure 1. Isolated wetlands like this lowland hardwood swamp reduce flood peaks by capturing and infiltrating runoff.

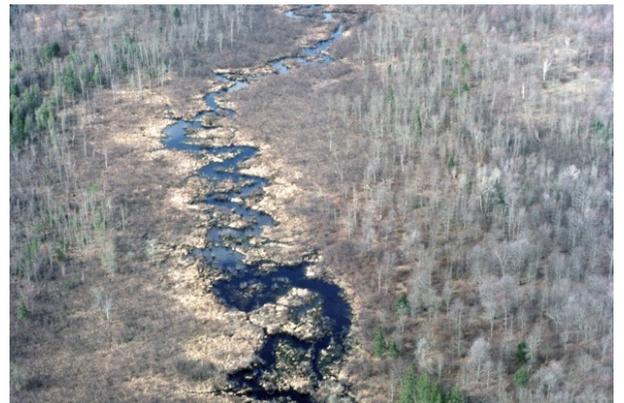
Figure 2. Healthy floodplain wetlands reduce the energy of runoff events by allowing the stream to spread out and slow down during high flow events. Photo: Eric Epstein

In healthy watersheds, historic wetlands remain relatively intact and work in aggregate across the landscape to help manage water. The work these wetlands do depends largely on wetland type, location, and condition. For example, geographically isolated wetlands in upper watershed areas reduce runoff by capturing, storing, and infiltrating vast quantities of rain and snowmelt (Figure 1). Further downstream, when storms cause a river's banks to overflow, the water spreads out across riparian and floodplain wetlands where it is held and filtered before slowly returning to the river (Figure 2).

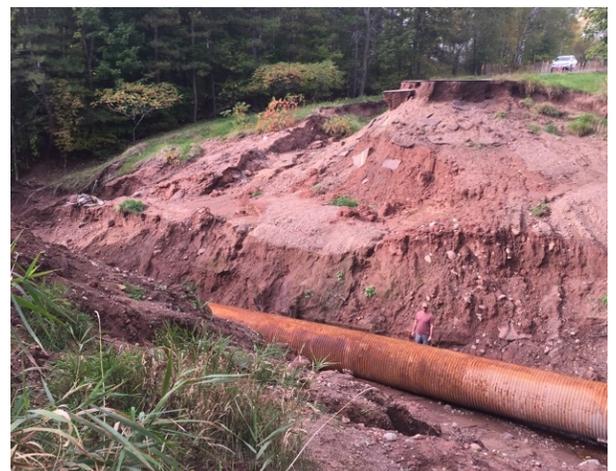
Figure 3. Road and culvert washouts were extensive and costly during the July 2016 storm.

Between July 11-13, 2016, a foot or more of water dropped across a large portion of Wisconsin's Lake Superior Basin, causing more than \$35 million in damage. Roads washed out, homes and businesses were inundated, and two lives were lost (Figure 3).

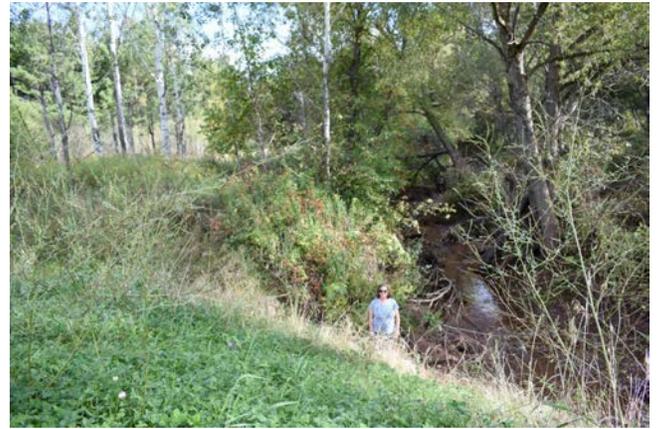
Figure 5. A wetland complex (upper left) is partially drained and substantially disconnected from the stream due to channel incision.

- **Indirect loss of storage through erosion-induced wetland drainage and floodplain disconnection** – Incised channels are a major cause of local floodplain and wetland deterioration. Channel incision accelerates surface and sub-surface flows into lower-elevation channels causing adjacent wetlands to be fully or partially drained. In cases where wetlands are adjacent to a stream, the incision can also result in a situation where the waterway can no longer interact with the former floodplain (Figure 5).

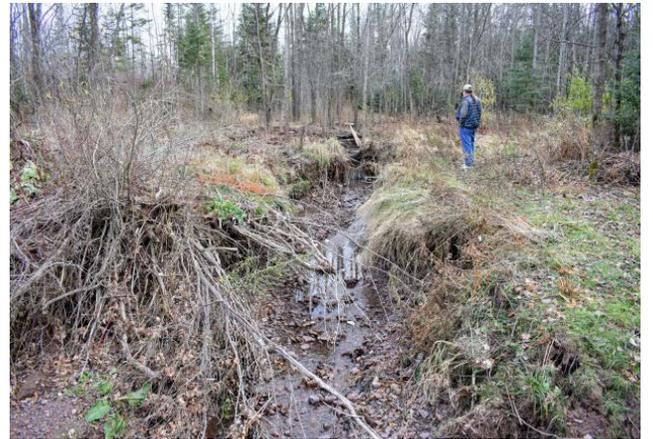
Figure 6. Headcutting is developing upslope from an undersized culvert, threatening to drain adjacent wetlands.

- Downcutting – incision from too much water in a constricted channel;
- Headcutting – incision upslope from pinch points such as culverts, bridges, and roads (Figure 6);
- Gully formation - incision from accelerated runoff and erratic groundwater flows through unstable soils.

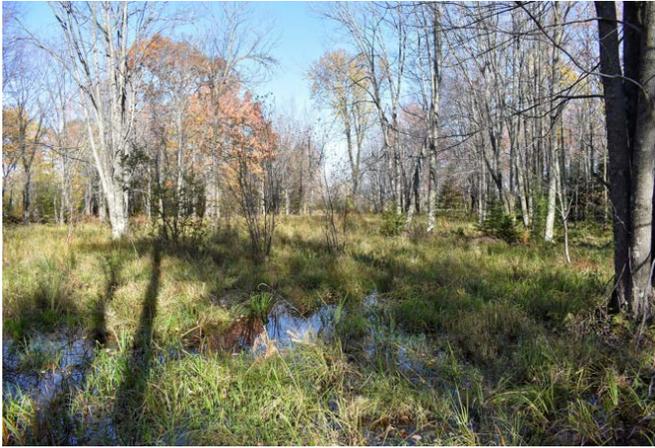
Figure 15. *An intact upper watershed wetland complex. Portions are grazed and hayed.*

A large wetland complex serves as the headwaters to an unnamed tributary to Silver Creek (Figure 15). This parcel provides numerous ecological functions and provides a tremendous amount of storage. Rain and snowmelt is held and slowly infiltrated. Until recently, any water running off the property was minimal, low energy, and dispersed through overland flow (Figure 16).

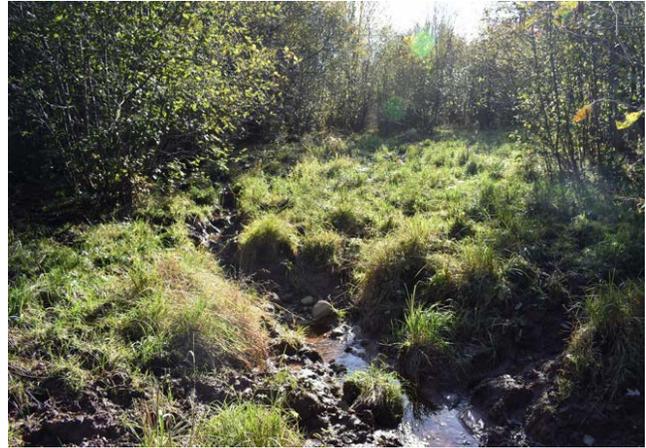
Figure 16. *The wetland complex has historically been drained by low-energy channels that help to control runoff.*

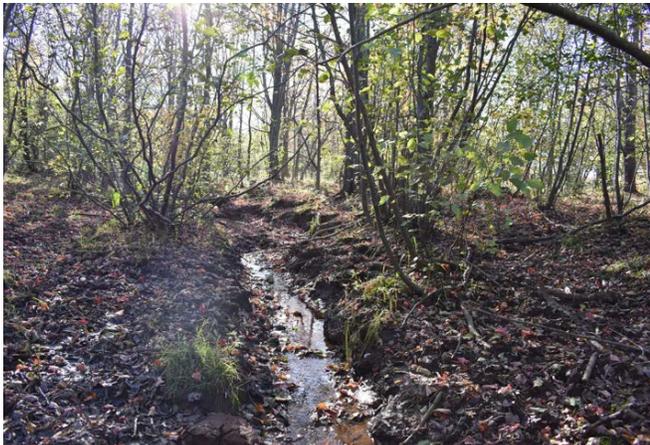
Figure 17. *An incised channel is developing at an outlet of the wetland complex in response to the 2016 storm.*

Post-storm, the channel is now accelerating surface and sub-surface flows out of the wetland complex (Figure 17). The farmer has observed sustained flows in the channel and drier conditions in the adjacent wetland complex.

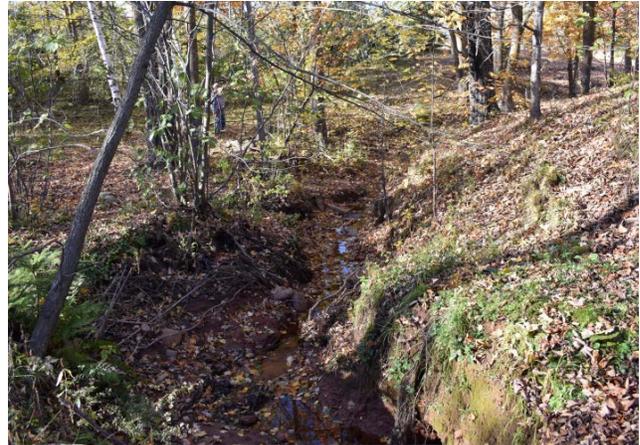
Figure 18. *Gully formation threatens to drain the upslope wetlands and worsen downstream conditions.*

Just down gradient, a headcut had been incrementally progressing upslope from an undersized culvert at Coria Road. Runoff from the 2016 storm alone accelerated this erosion, deepened the existing channel, and advanced the headcut to where it finally reached and carved a channel into the wetland (Figure 17 and 18). The culvert also washed out by the end of the storm.

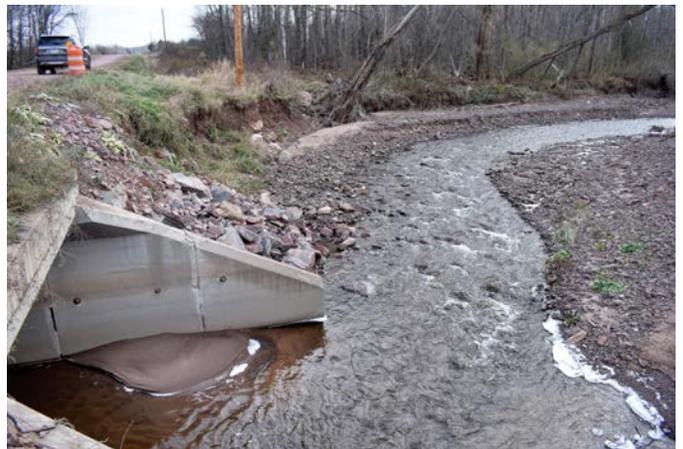
Figure 19. *This misaligned and undersized culvert is vulnerable due to upper watershed hydrologic disturbances.*

This brings us to a vulnerable culvert at Delafield Road just below the confluence of this unnamed tributary and Silver Creek (Figure 19). This culvert and the associated road repeatedly wash out during storms events. In addition to the upstream conditions described above, several site-specific factors contribute to this instability.

For example, the floodplain just above the culvert is disconnected by in-stream channel incision, preventing flood flows from spreading out across the floodplain. Natural stream system features such as meanders, oxbows, and anabranches that help water take the path of least resistance are not forming, or available, to manage flows.

The built-up, higher-elevation road also acts like a dam. Flood flows back up behind it, placing a tremendous amount of pressure on the road itself. The adjacent streambanks and road fill are scouring away since flows are forced to take a sharp turn into the misaligned culvert. Because channel migration is accelerated in streams disconnected from their floodplains, repetitive road and culvert failure will remain highly probable until infrastructure is aligned appropriately and designed to improve stream-floodplain connectivity.

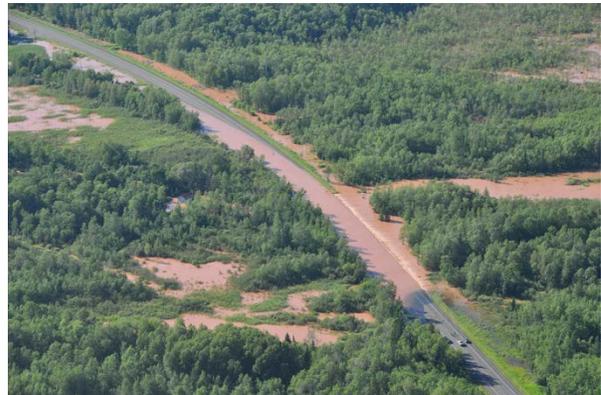
Figure 20. *The low-lying elevation of U.S. Highway 2 and intact floodplain allowed flood flows to spread out and overtop the road without causing major damage. Photo: WI Emergency Management*

This combination of intact floodplain and wetland functions upstream and downstream of the highway, and good road design, renders much of this U.S. Highway 2 corridor notably more resilient than other local roads, culverts, and bridges.

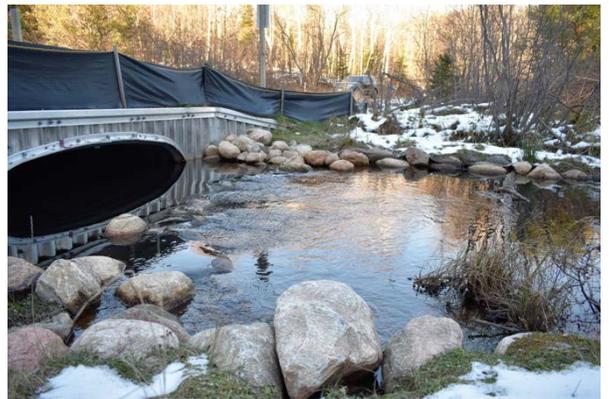
Figure 21. *In-stream grade stabilization structures, such as this one installed downstream of a culvert on the Chequamegon National Forest, can help to reconnect surface water with upstream riparian and floodplain wetlands.*

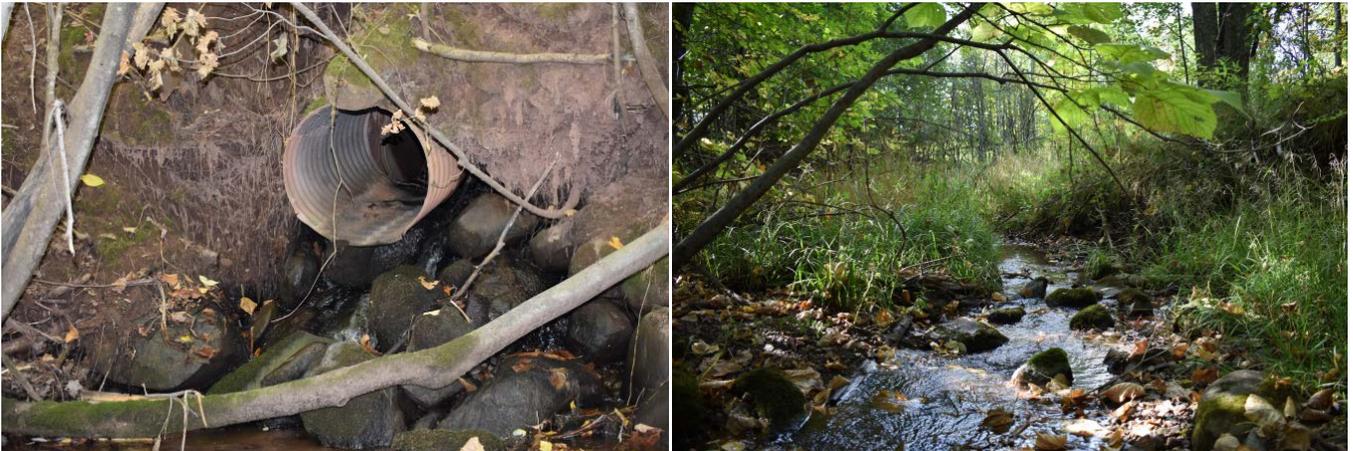
Culvert Design and In-Channel Grade Stabilization

A perched and undersized culvert (left) obstructs flows into riparian wetlands (right) along an upper watershed stream network. Flows currently seep under the road fill and inconsistently provide pulses that promote healthy hydrology and vegetation conditions. During future road repairs, grade stabilization, improved stormwater passage, and engineered structures could help divert flows into drier portions of the larger wetland complex and stimulate further wetland generation (i.e., providing more storage).

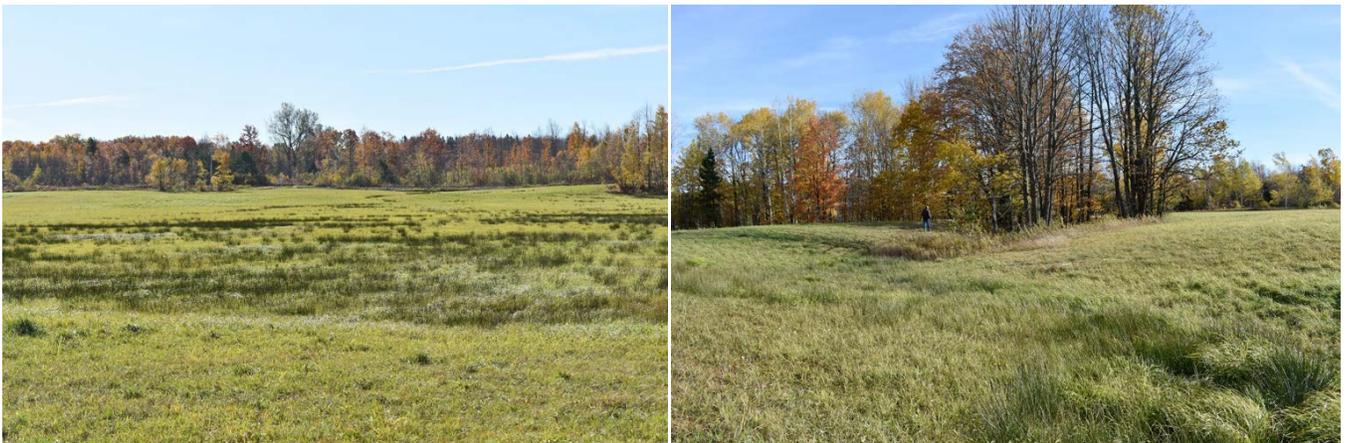
On-farm Water Management

A productive hay field (left) has begun to drain due to gully erosion (right). Efforts to armor the channel with rock have not arrested the headcutting in the gully/ravine system. Grade stabilization and a water control structure could help lift the gully to grade and hold more water on the fields during snowmelt, spring rainfall, or when runoff is highest and hay production will not be harmed. These practices maintain land productivity and would also match well within a grazing operation.
